Bat roost assessment of woodland areas and trees for proposed new prison, bowling club, and boiler house on land adjacent to HMP Garth and HMP Wymott, Leyland

Project: Garth Wymott 2

Document number: 608623-0000-CGO-GHX0000-XX-RP-X-0006

Deliverable: Bat roost surveys of woodland and trees

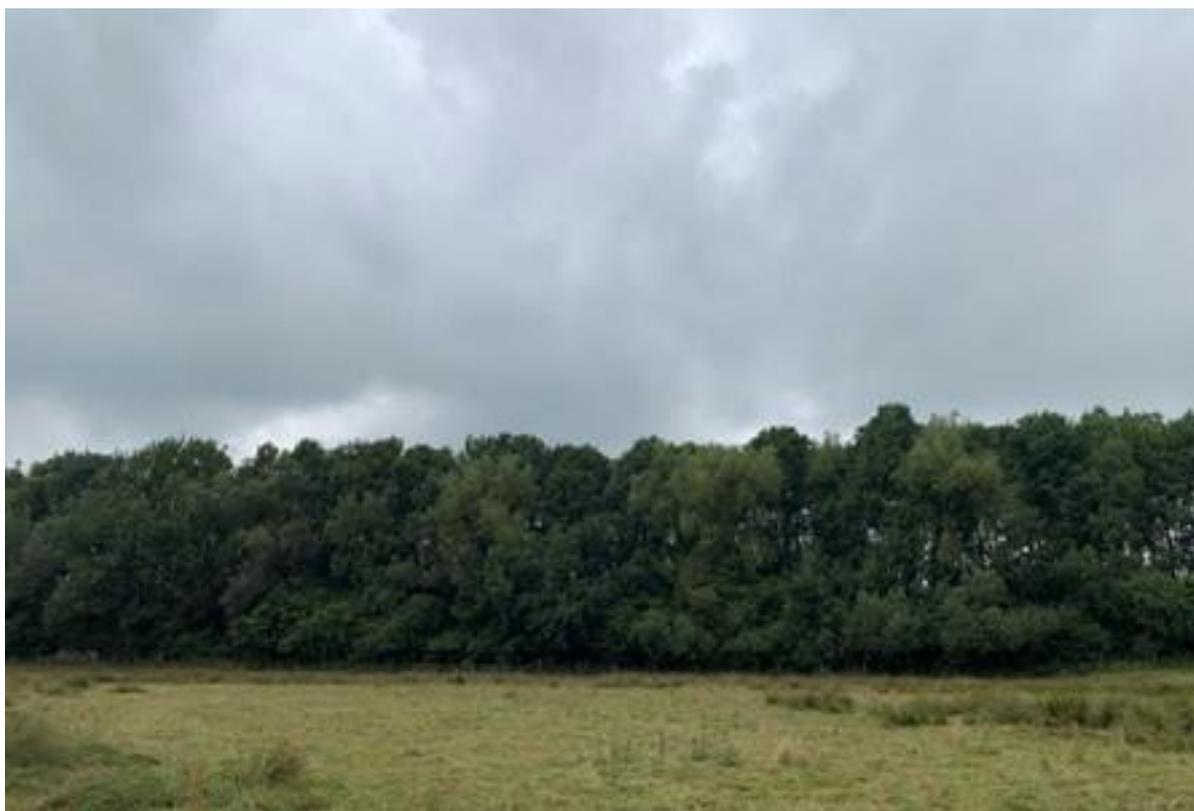
Plate 1 – Woodland north of existing boiler house, subjected to aerial inspection. Looking north.

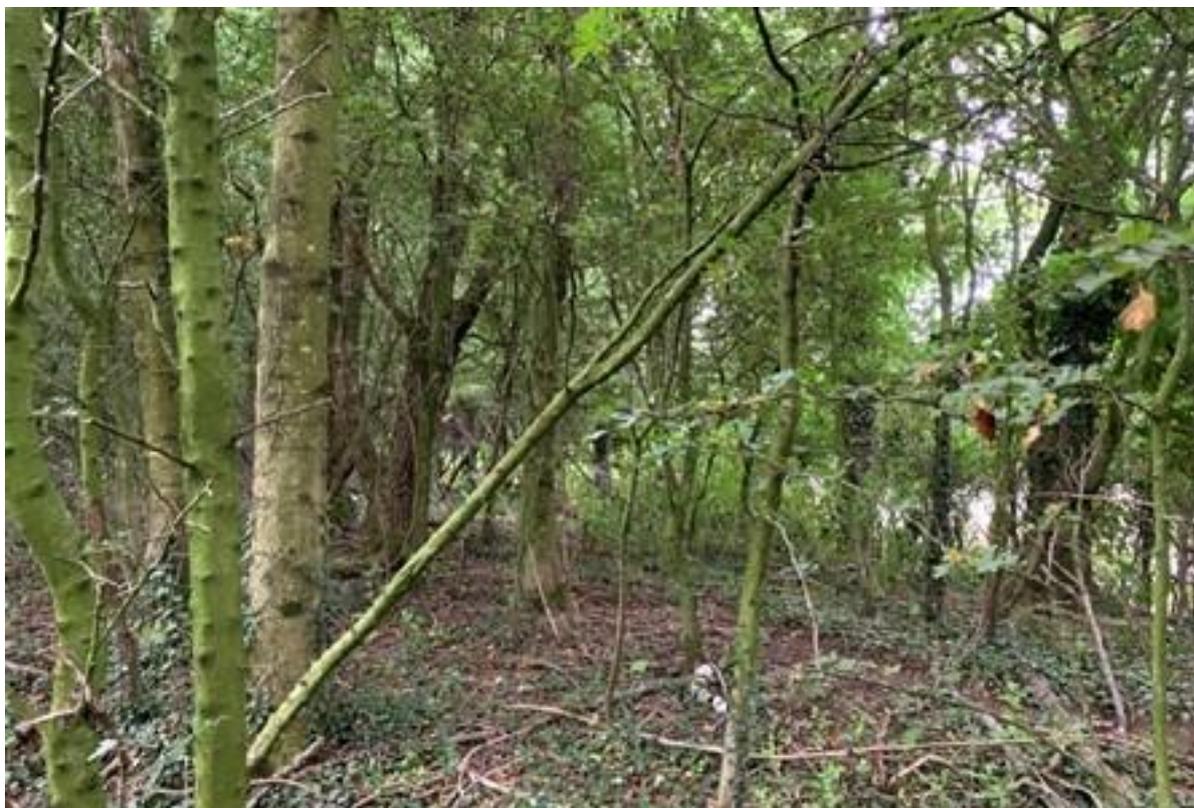
Plate 2 – Woodland north of existing boiler house. Dense understory of saplings preventing full ground-level inspection, and therefore requiring aerial inspection.

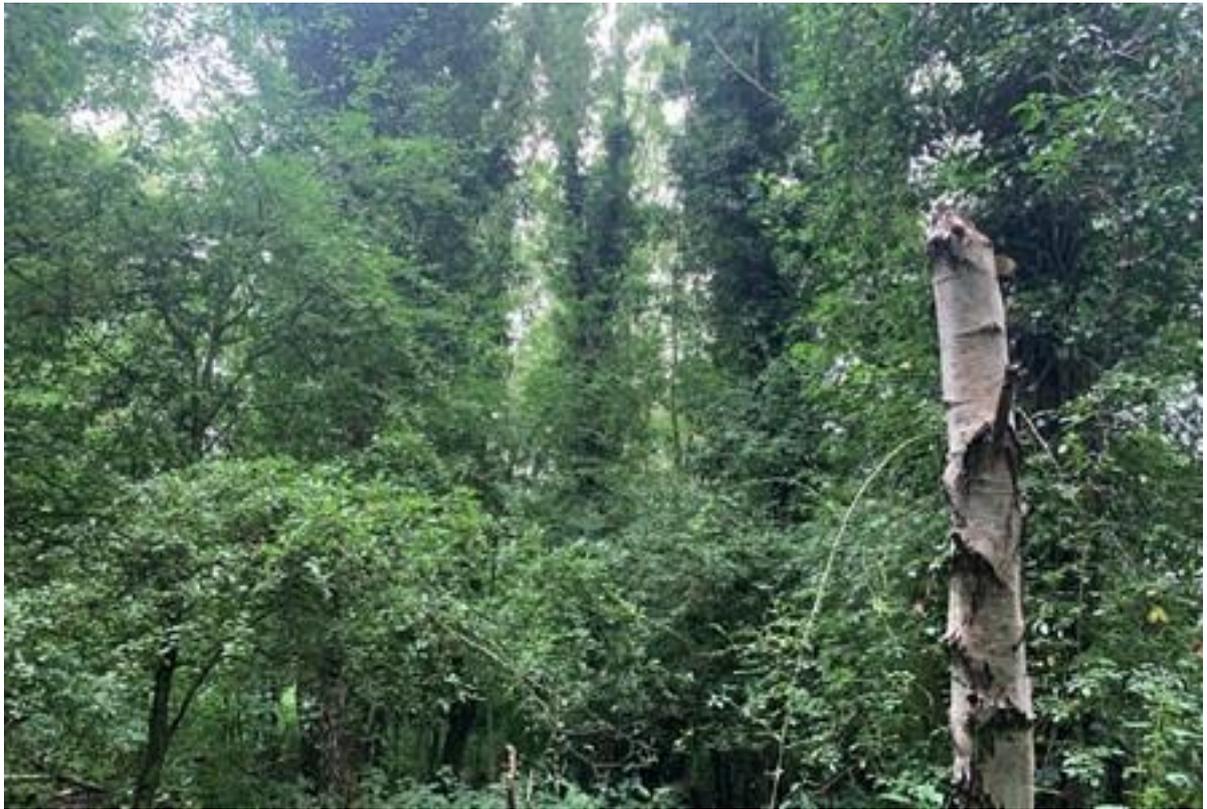
Plate 3 – Woodland north of existing boiler house. Trees with ivy cover were climbed and inspected to check for hidden features.

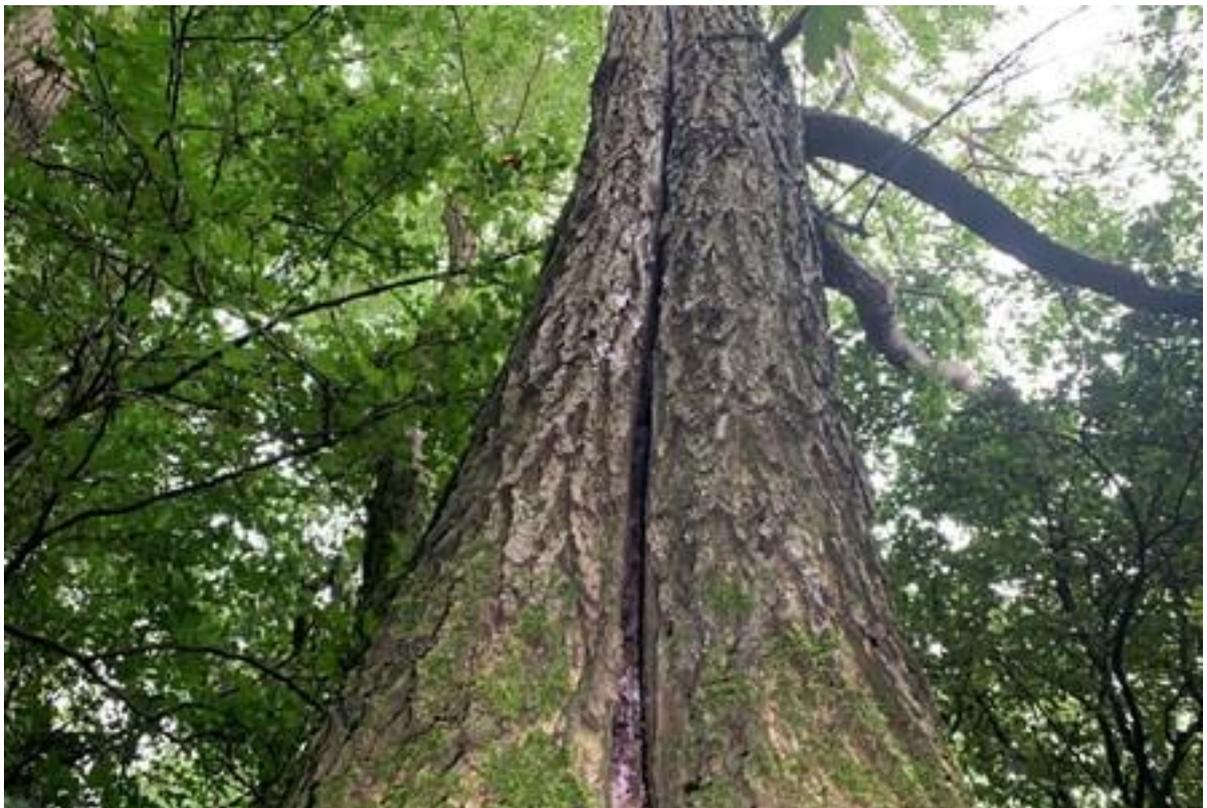
Plate 4 – Woodland north of existing boiler house. Trees with minor splits and cracks in bark were inspected in detail.

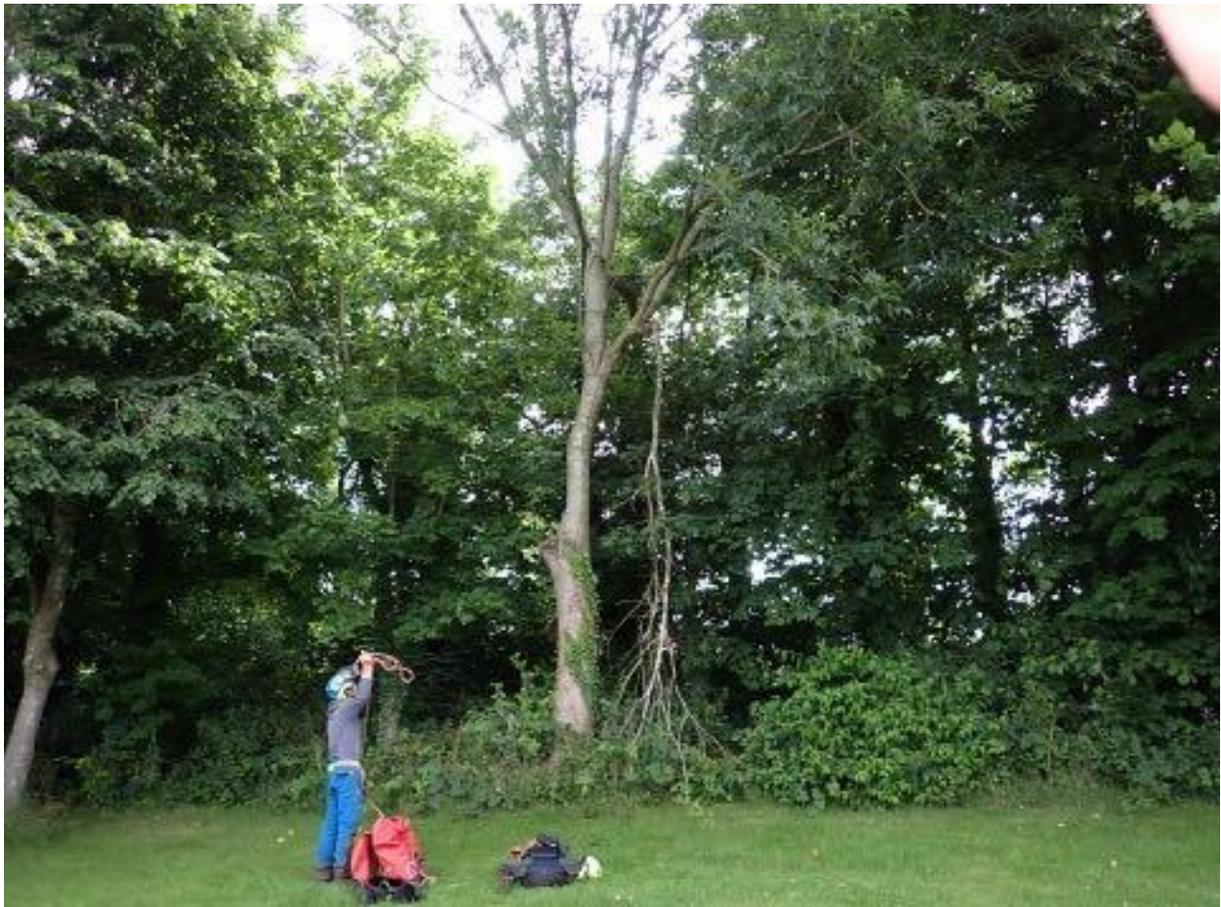
Plate 5 – Tree T13. Ash tree on west side of small copse of trees adjacent bowling green and amenity grassland. Pruning wounds, snapped and dead limbs in the crown and tear outs on lead stems. Negligible.

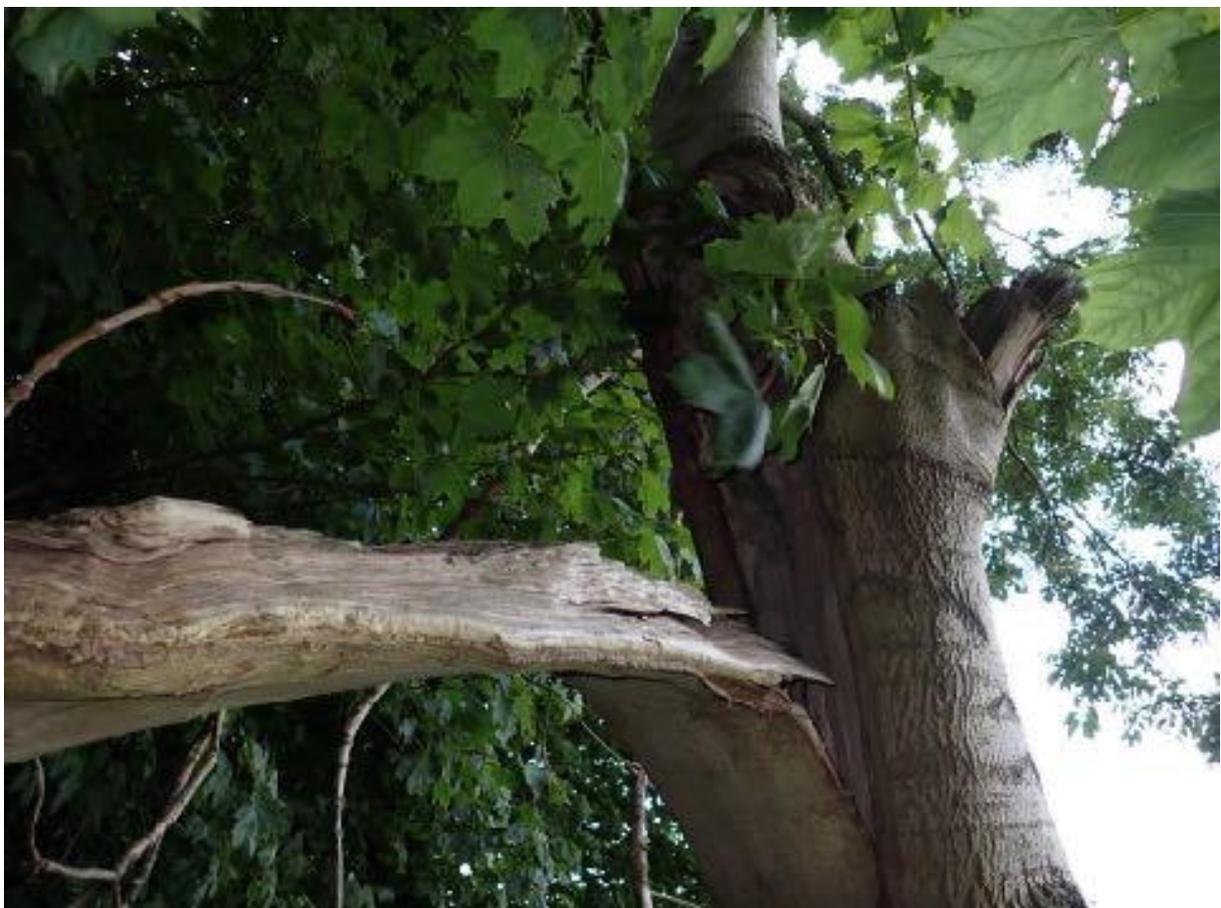
Plate 6 – Tree T13. Tear out at 2m on east side of main stem with 1m x 30cm of bared heartwood with no suitable cavity. Negligible.

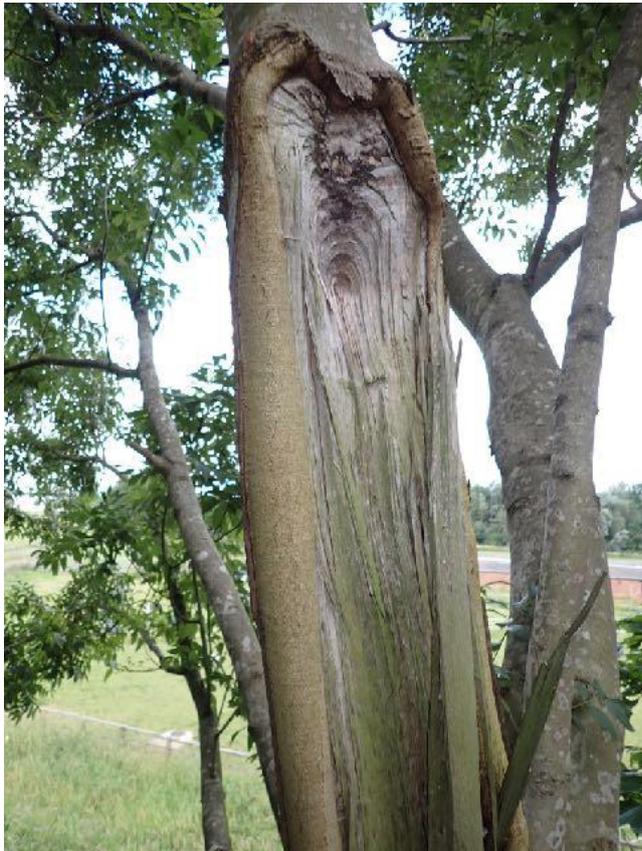
Plate 7 – Tree T13. Tear out at 8m on east side of main stem with 1m exposed heartwood with no suitable cavity. Negligible.

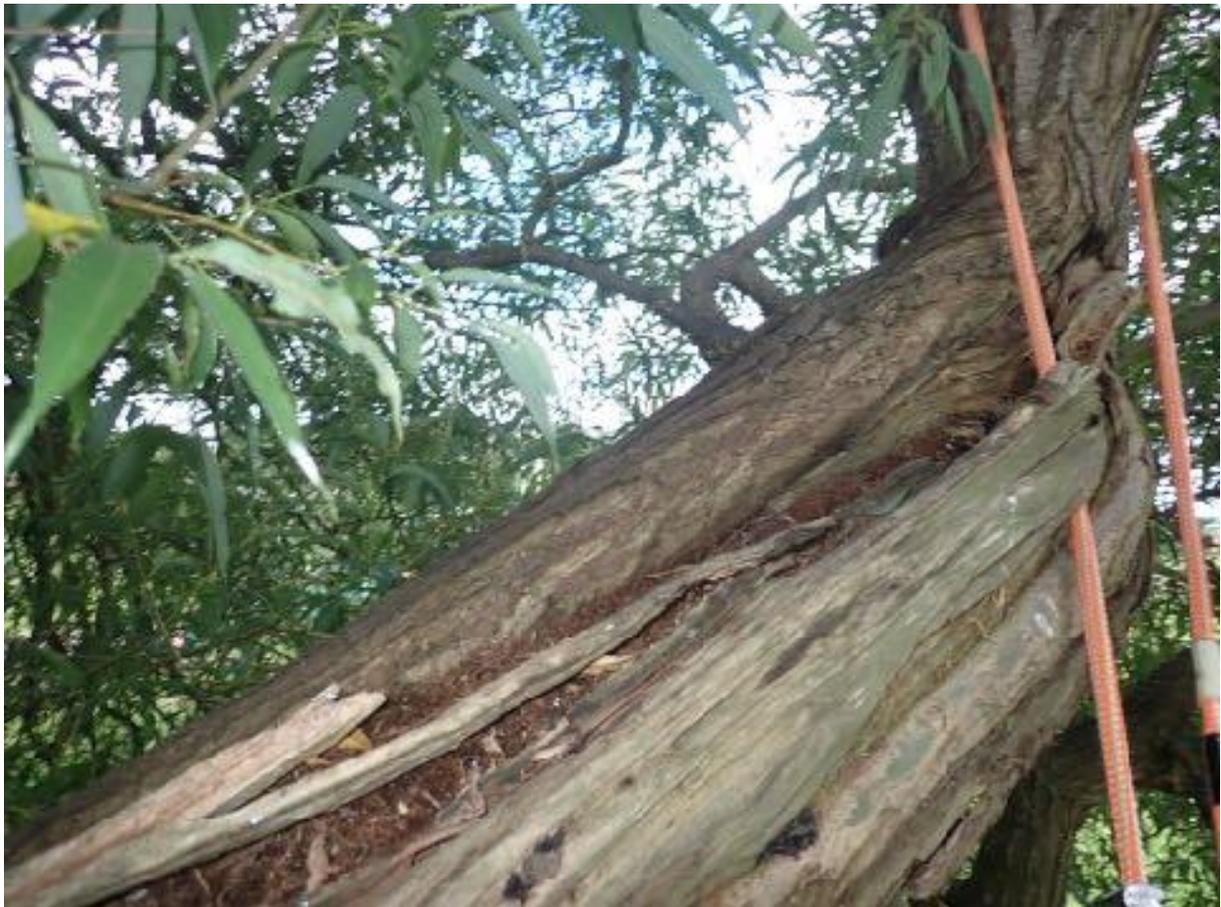
Plate 9 – Tree T2. Tear out at 5m on top of diagonal limb in the north side of the crown. Exposed and rotting heartwood 1m x 20cm with no suitable cavity. Negligible.

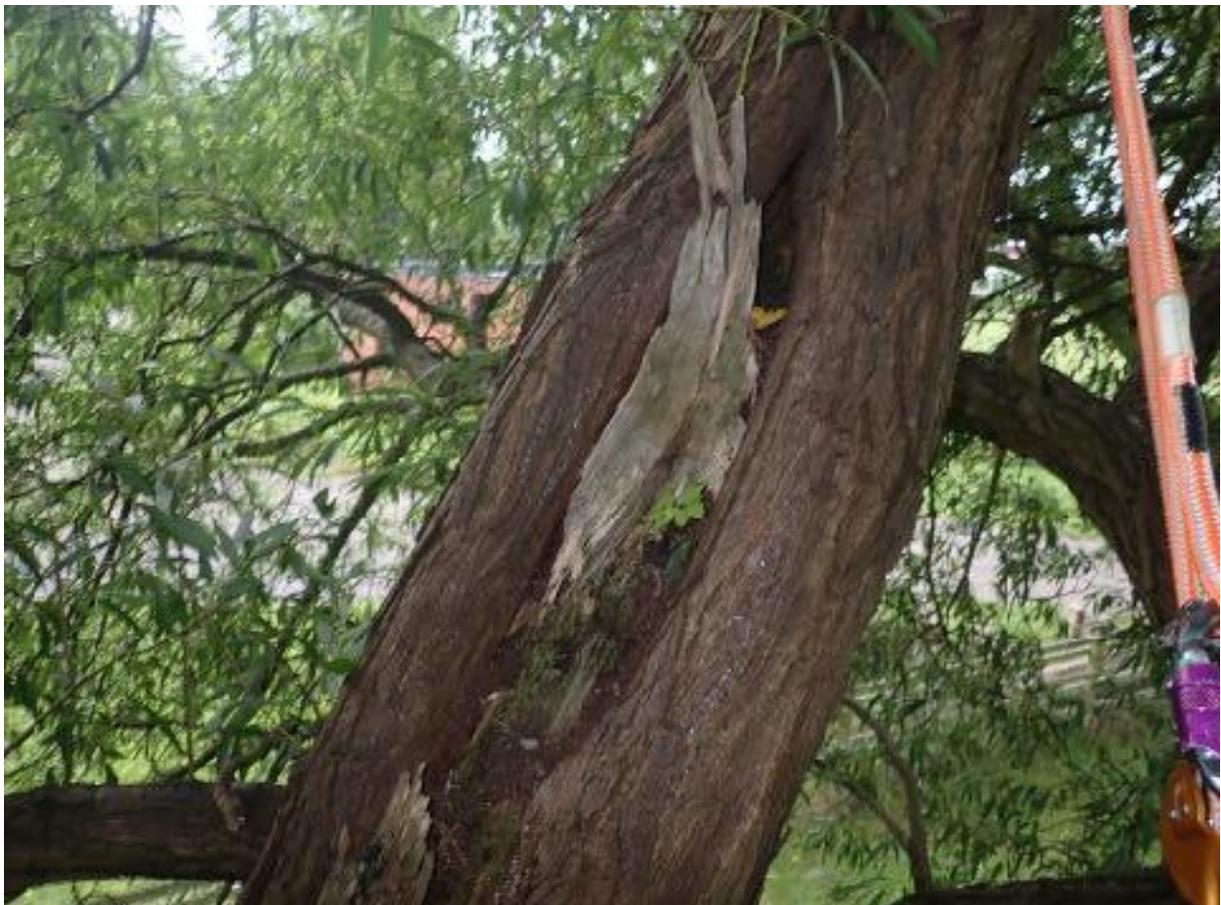
Plate 10 - Tree T2. Tear out on inside of diagonal lead stem at 5m in the west side of the crown. 1m x 20cm of bared heartwood with minor cavity at top of feature with 5cm upward travel. The feature is packed with slugs. No gaps around callus rolls. Negligible.

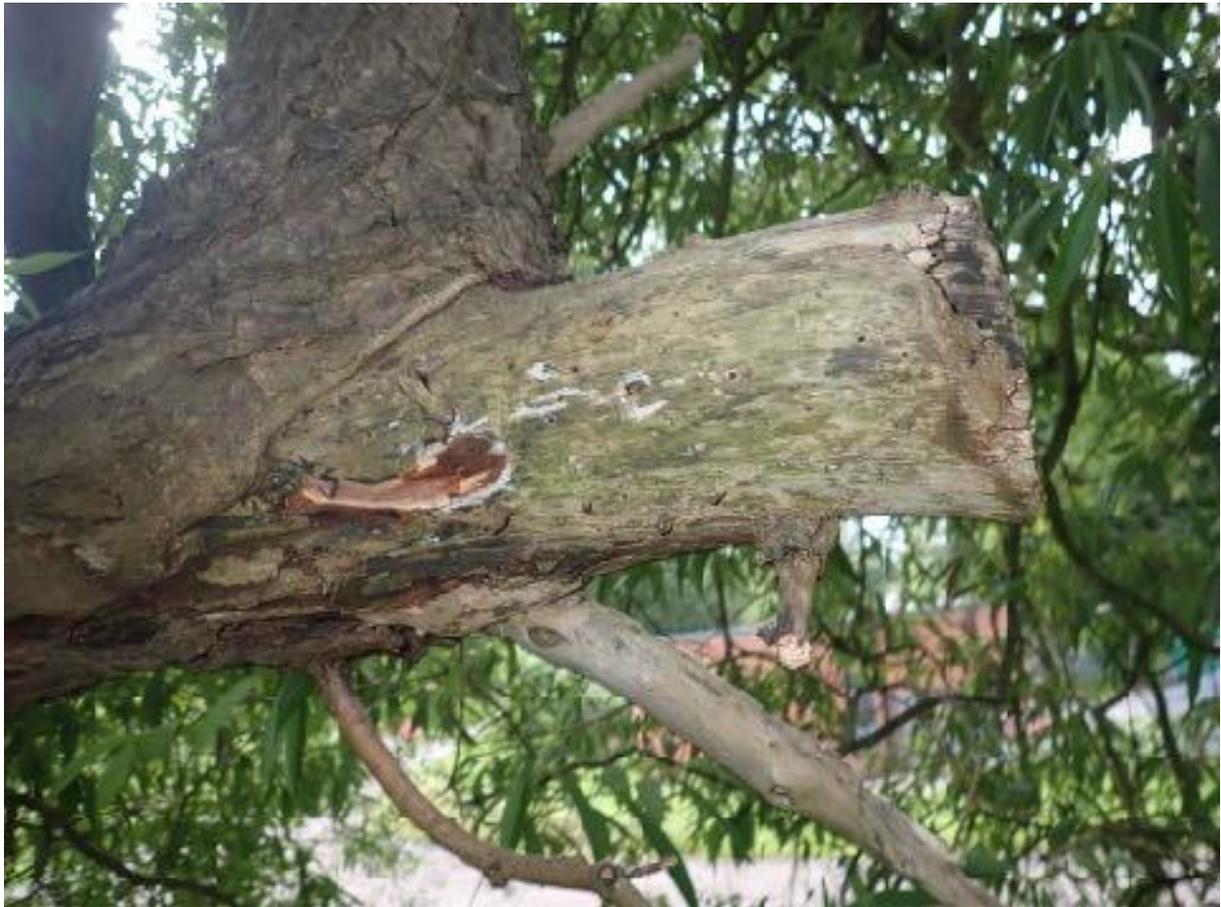
Plate 11 - Tree T2. Pruning injuries at various heights throughout the crown were checked, none have suitable features for roosting bats. Negligible.
