Phase I & II Geoenvironmental Site Assessment
Land adjacent to HMP Garth, HMP Wymott

Reference:14-451-R1-2
Date: August 2021

PHASE I & II GEOENVIRONMENTAL SITE ASSESSMENT

Land adjacent to HMP Garth
HMP Wymott
Leyland

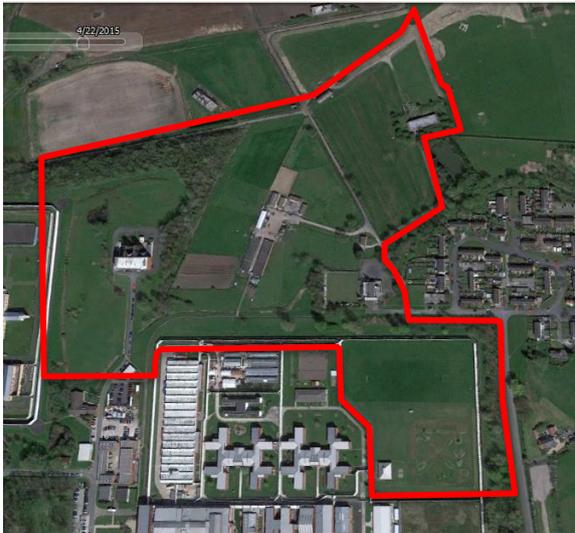
<p>2015 Google Earth Imagery</p>	<p>There are no significant changes.</p>

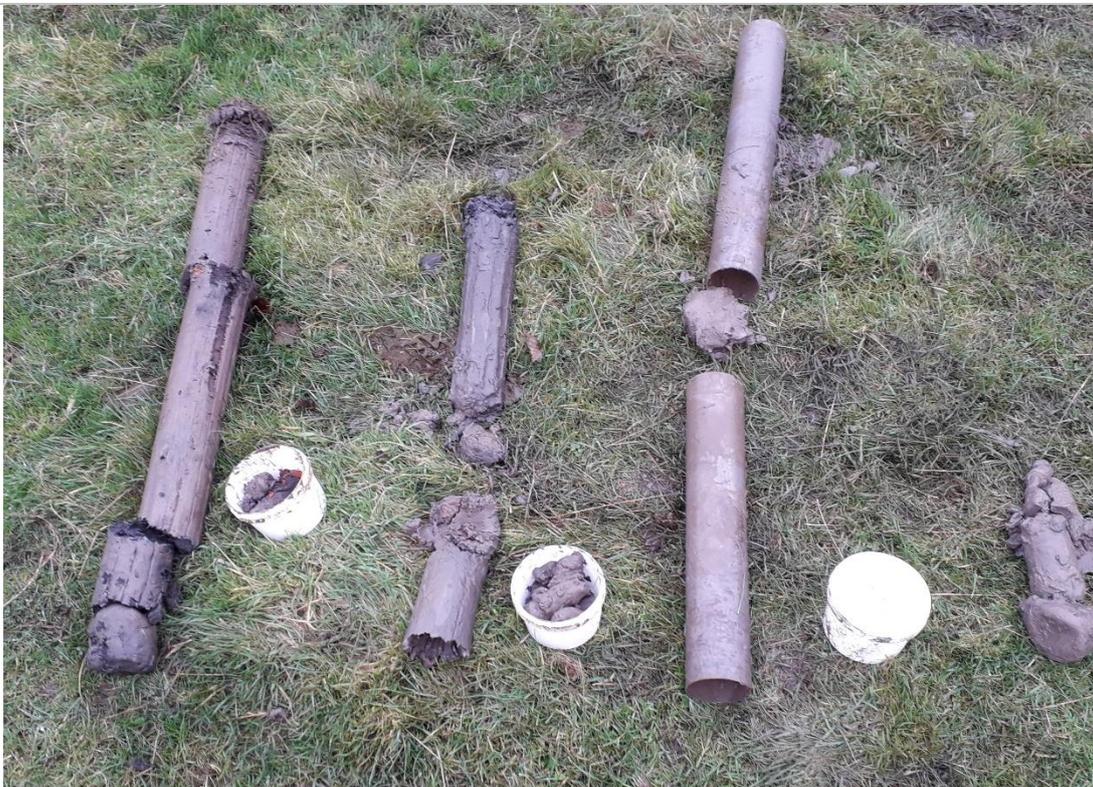
PLATE 7 WS106 ARISINGS

A hydrocarbon odour was noted in WS106 between 0.80 m to 1.00 m bgl. A relict topsoil layer was identified between 0.40 m and 0.60 m bgl and organic matter was also noted in WS106 between 0.80 m to 1.50 m bgl.
